# New York State Department of Transportation

## Yellow Flag NB2222W007

**BIN: 1065318**  
**Feature Carried:** 278I278IX2M23027  
**Feature Crossed:** 6TH AVENUE  
**Orientation:** 8 - NORTHWEST  
**Region:** 11 - NEW YORK CITY  
**County:** KINGS  
**Political Unit:** City of NEW YORK  
**Approximate Year Built:** 1962  
**Posted Load Matches Inventory :** Yes  
**Bridge Load Posting (Tons) :** Not Posted for Load  
**Primary Owner:** New York State Department of Transportation  
**Primary Maintenance Responsibility:** 12 - State - Subcontracted to another Party  
**Typical or Main Span Type:** 3 - Steel, 02 - Stringer/Multi-Beam or Girder  
This Bridge is not a Ramp  
**Number of Spans:** 322

Location: Span 253, Girder G16 at Pier 253

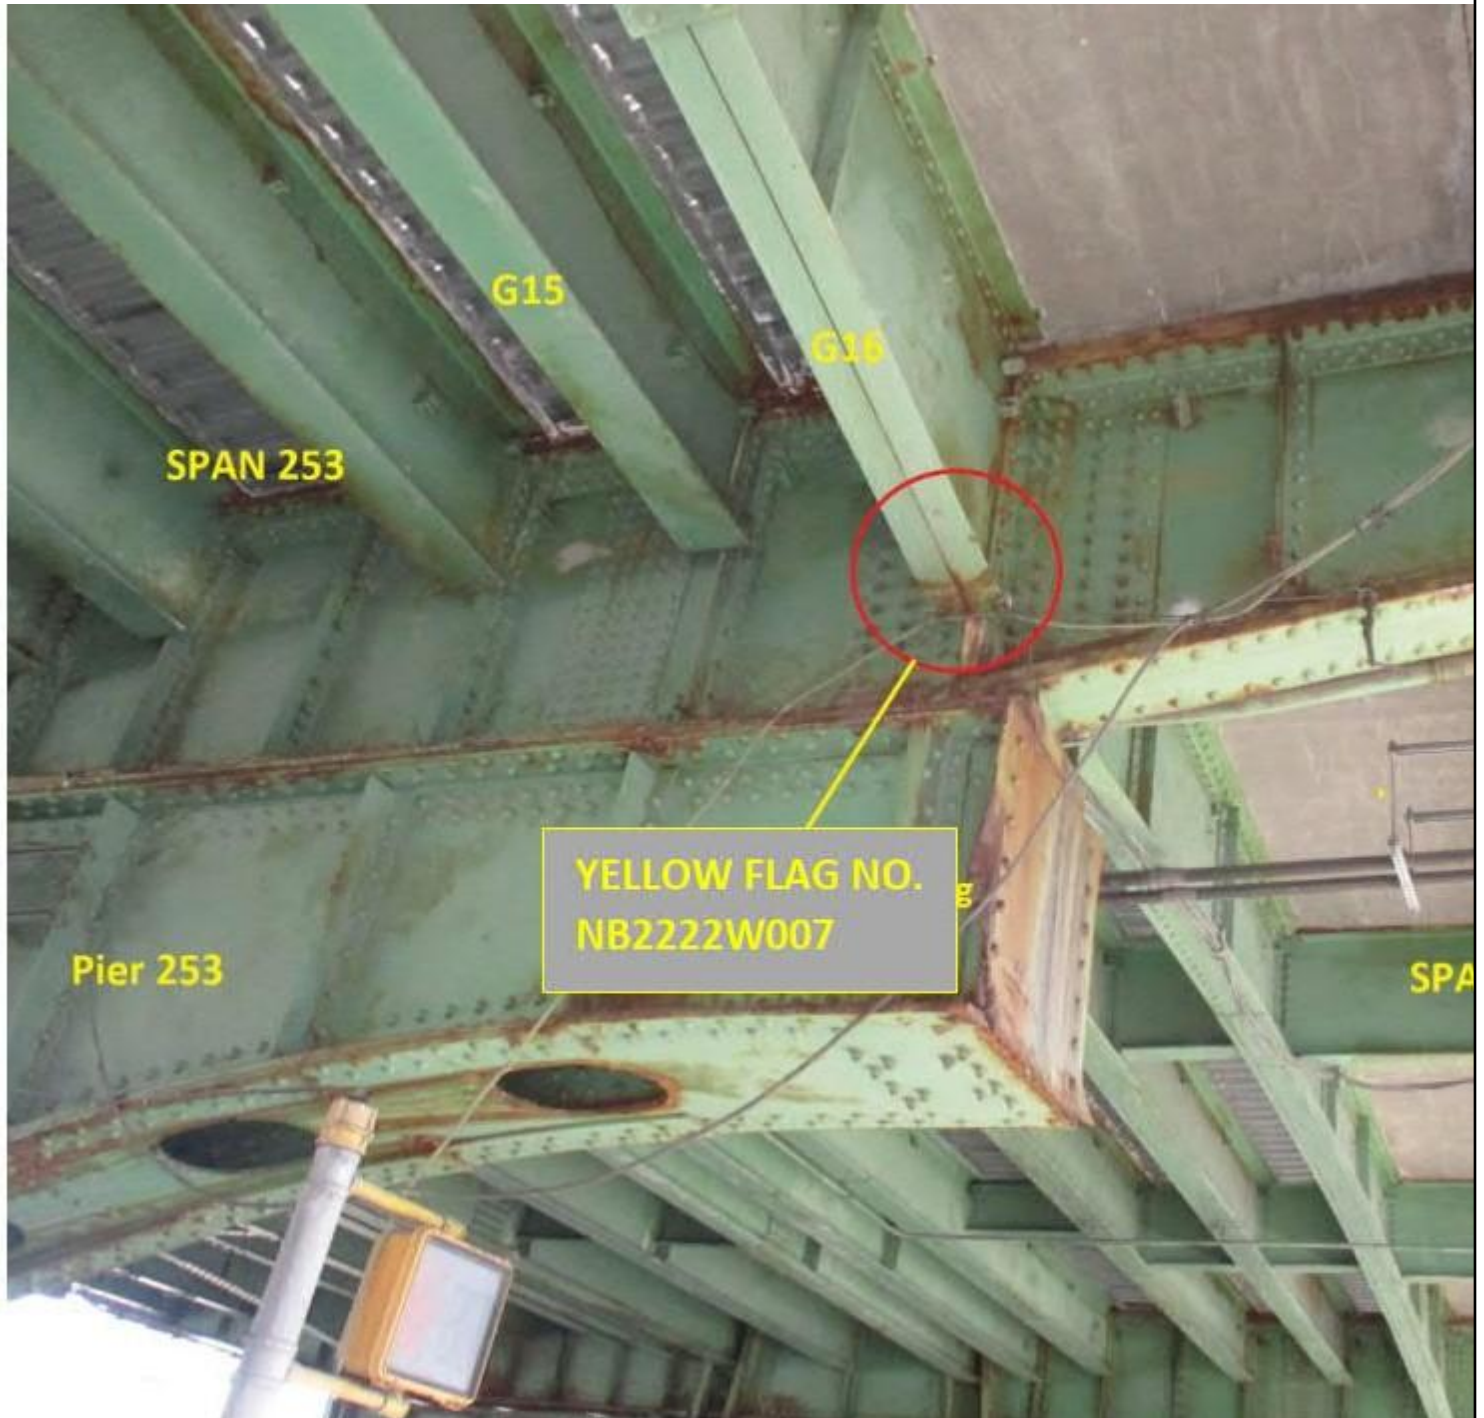
Photo Number: 1

The affected member Girder G16 is a load path redundant built-up steel girder consisting of varying web depth x 3/8" thick and two equal leg angles (L 5" x 5" x 1/2") for the top and bottom flanges (Photo 2). The spacing between Girder G15 and G16 is 3'-9.75" on center and 6'-11" on center from G17 (Photo 1).

**Attachment Description:** Span 253, Girder G16 at Pier 253. General View of flagged location. Looking end.

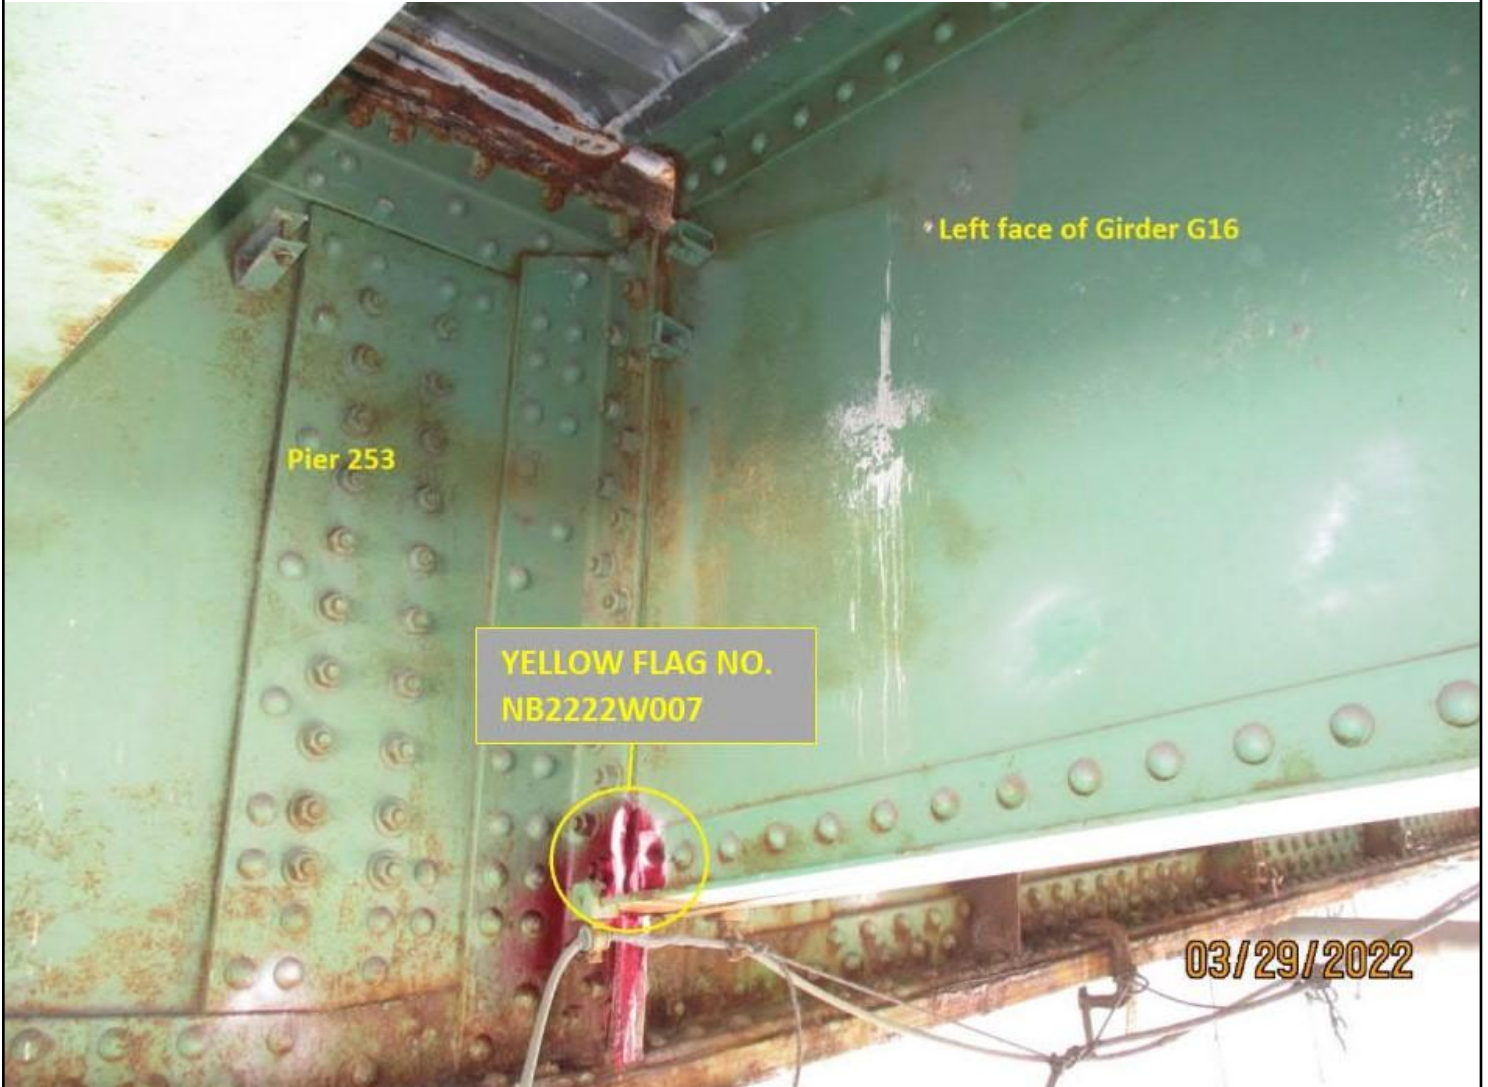
Photo Number: 2

**Attachment Description:** Span 253, Girder G16 left face at Pier 253. Close-up view of flagged location. Looking end right.

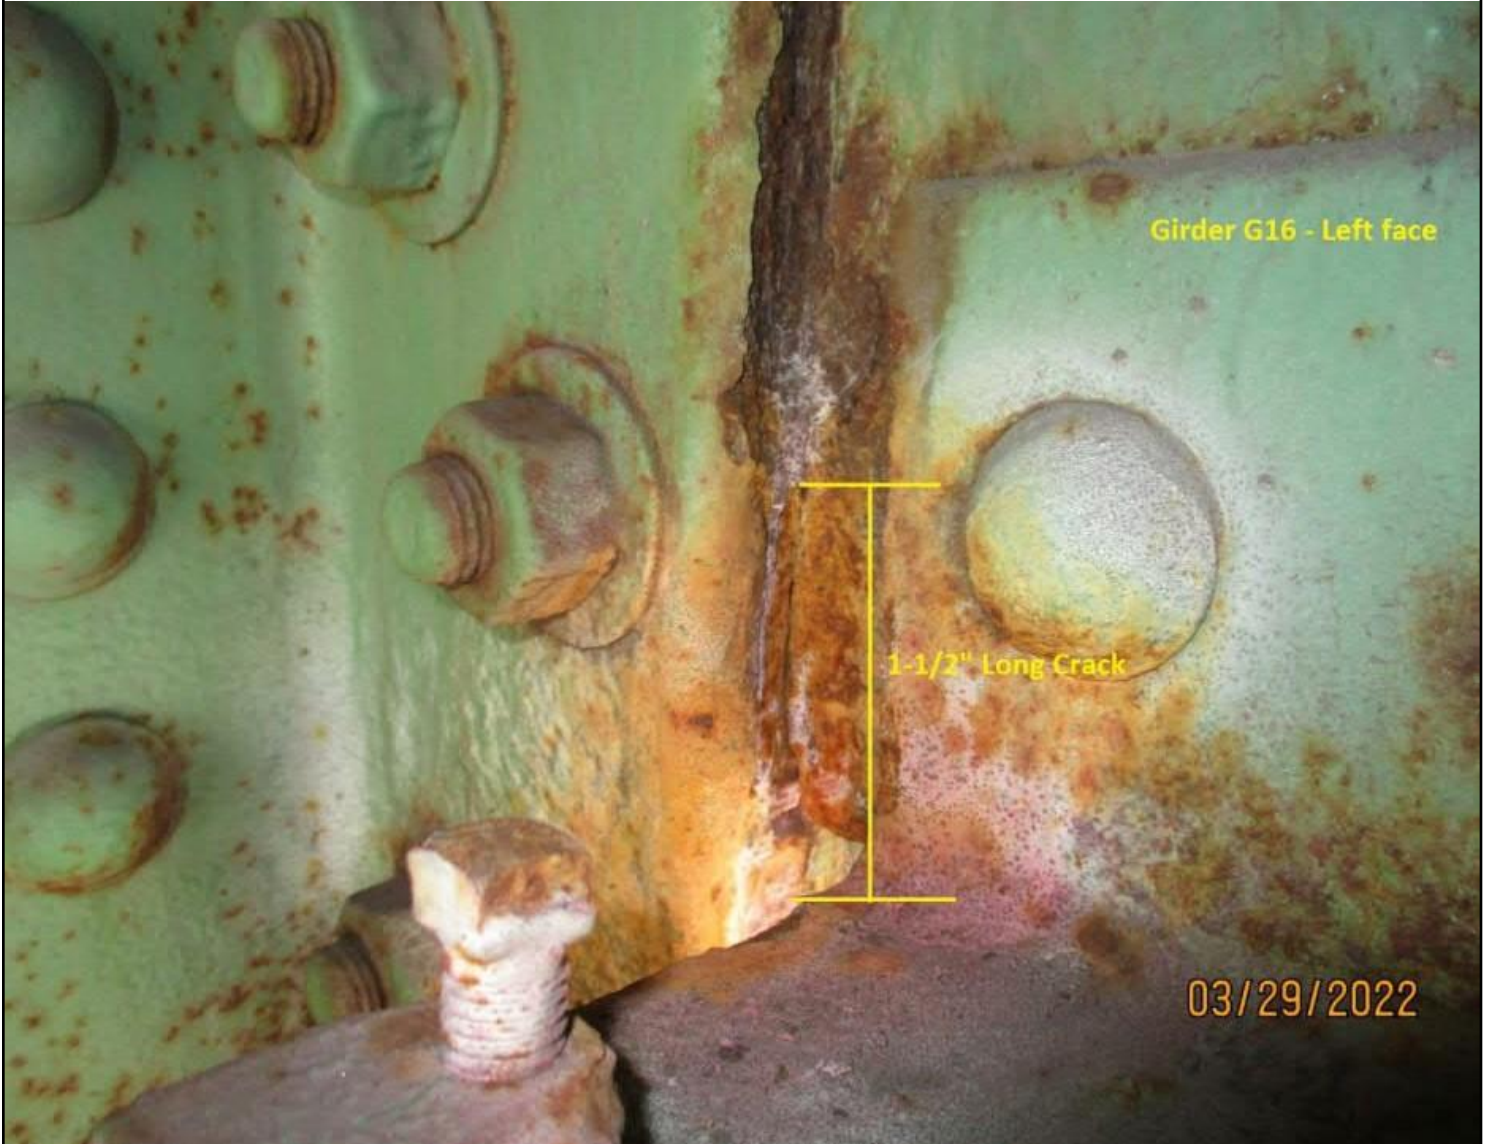
Photo Number: 3

Description: The bottom web of the Girder G16 at the connection angle exhibits a 1-1/2" long vertical crack (previous 1-1/8") initiating from the bottom cope and extending into connection angle (Photos 3 and 4). A Dye Penetration test was performed on the member to determine the extent of the crack.

**Attachment Description:** Span 253, Girder G16 left face at Pier 253. 1-1/2" long vertical crack at lower web before dye test. Looking end right.

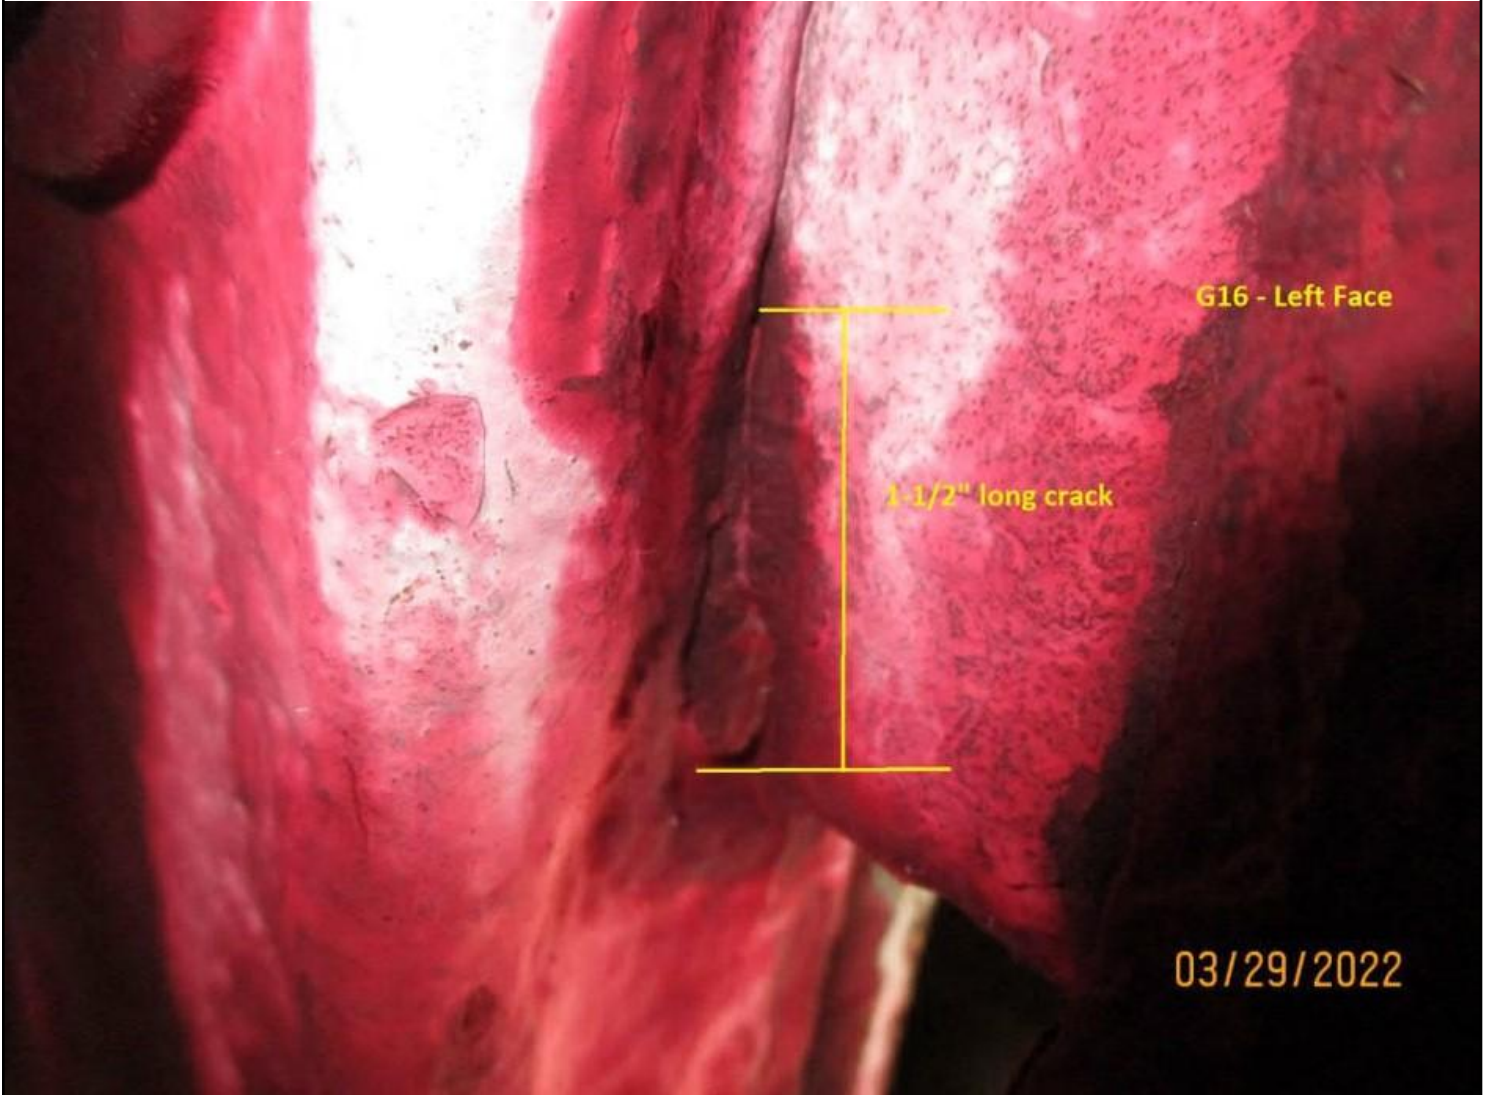
Photo Number: 4

**Attachment Description:** Span 253, Girder G16 left face at Pier 253. 1-1/2" long vertical crack at lower web after dye test. Looking right.

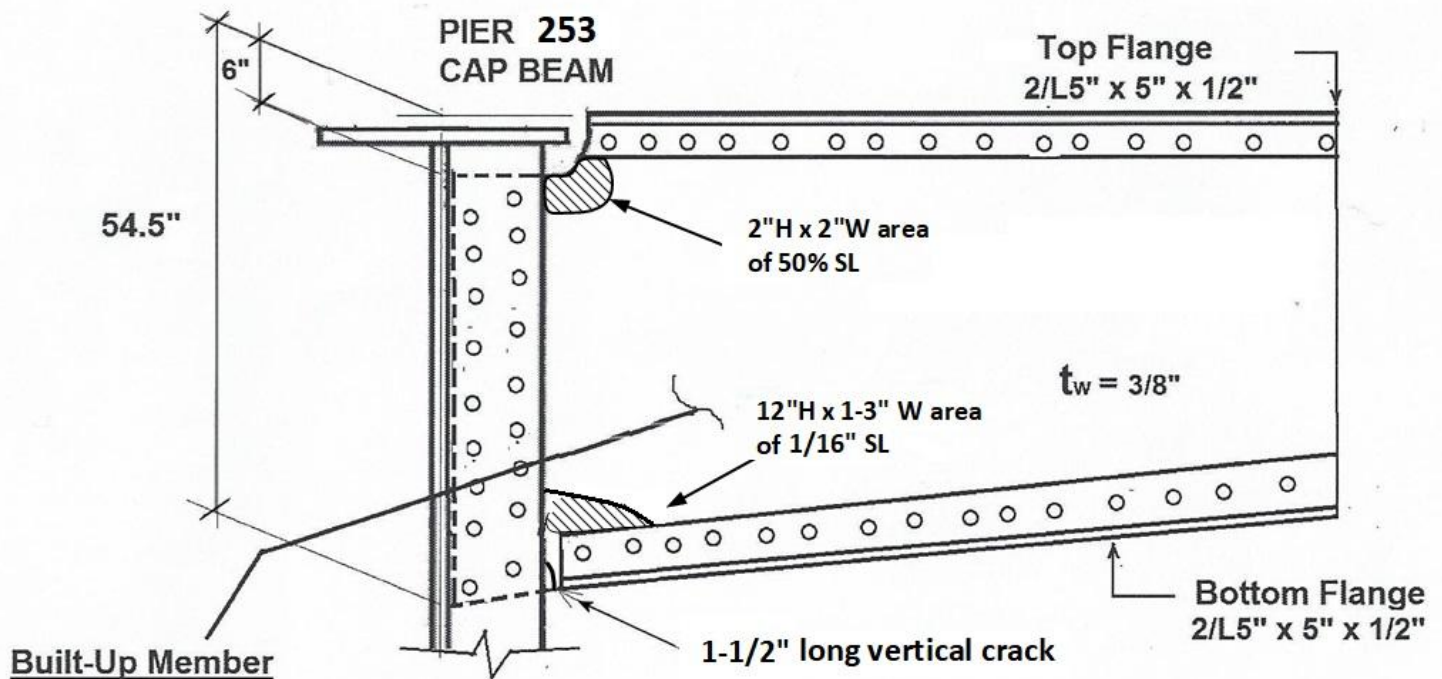
Photo Number: 5

Vary depth web: 54.5" b-to-b Ls @ Piers 252 and 253 and 33" @ midspan

Web thickness = 3/8"

Bottom and Top Flanges are two equal leg angles L 5" x 5" x 1/2"

*Attachment Description: SN 253 G16 at Pier 253 Sketch*

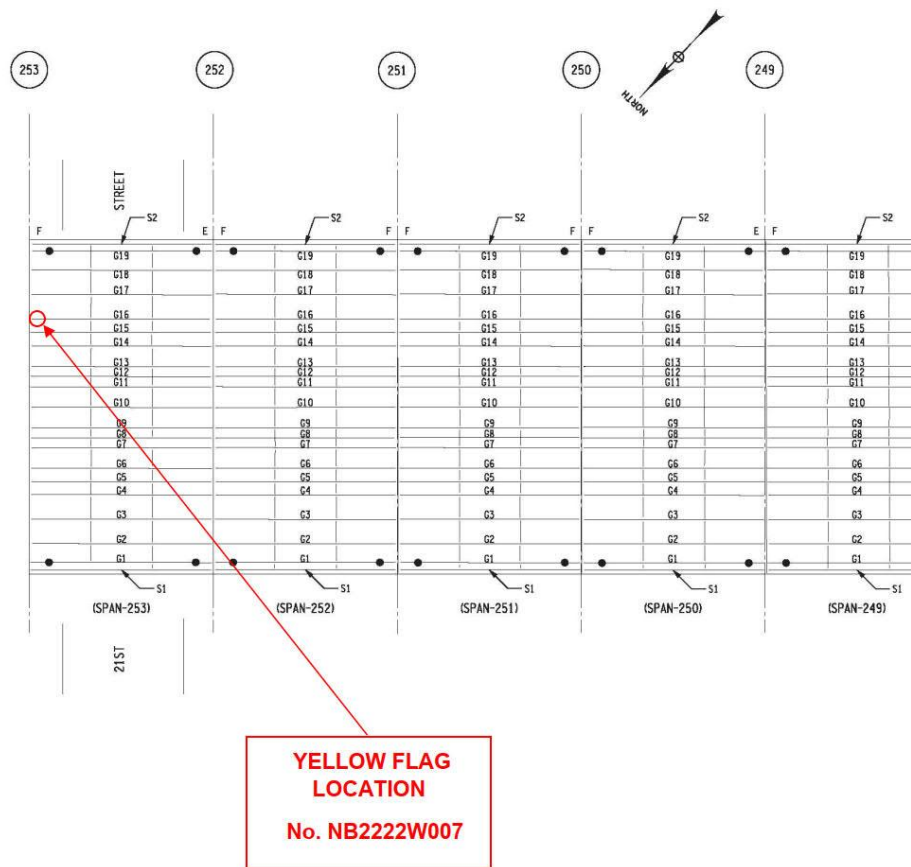
Photo Number: 6

**Attachment Description: SN 253 G16 ay Pier 253 Framing Plan**
